CASE OF THE MONTH (October 2007)

Signalment and History:

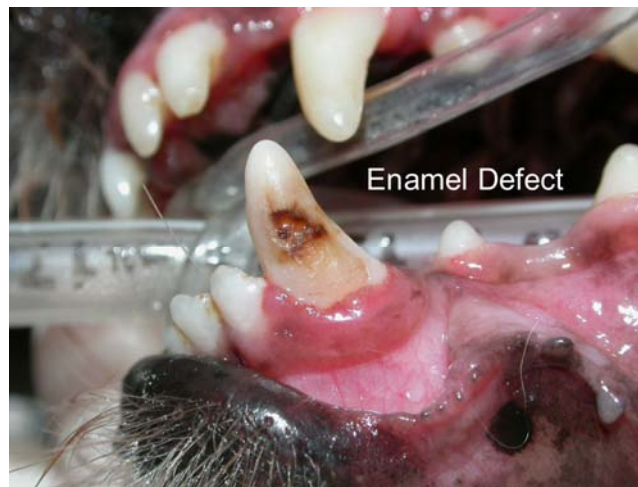
A ten year old neutered male Maltese presented with an enamel defect on the buccal surface of the left mandibular canine tooth. The exposed dentin and the edges of the remaining enamel had picked up a heavy stain as a result of exposure to the oral cavity.

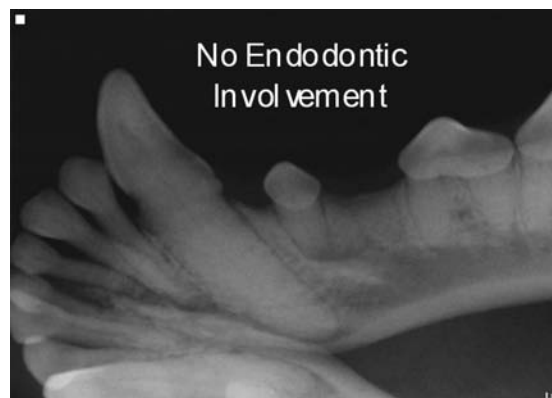
Procedures: An intraoral radiograph was taken in order to assess the endodontic health of the affected tooth. The root canal was normal in size, the periodontal ligament space appeared to be normal, and there was no periapical lucency or any other sign of endodontic disease.
