CASE OF THE MONTH (November 2009)

Signalment and History:

COMMUNITY ANIMAL HOSPITAL

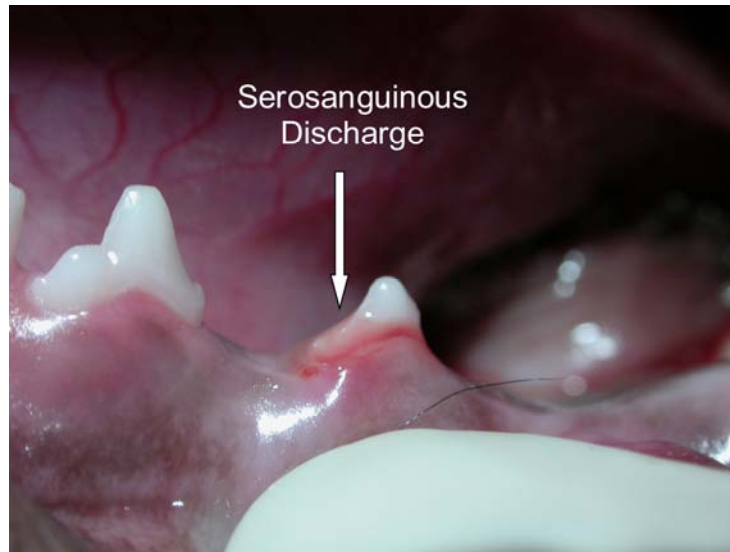
We discovered that the deciduous canine tooth had a fracture with pulp exposure.

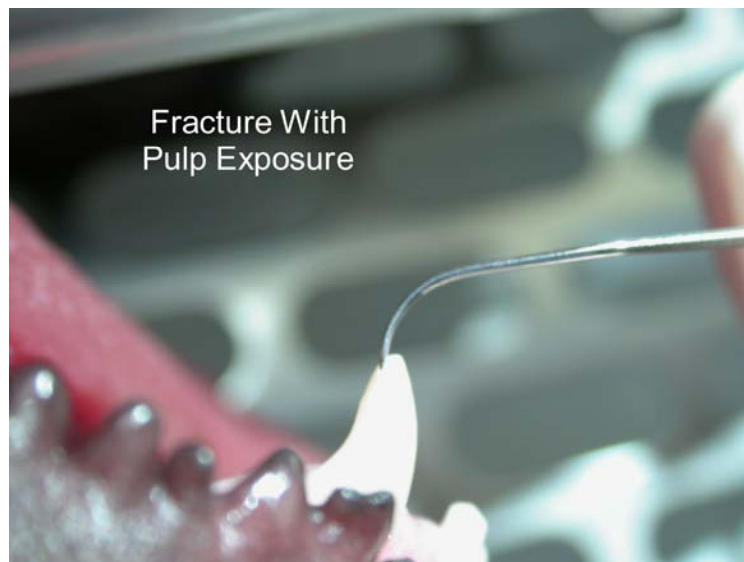
Intraoral radiographs revealed a radiolucent area near the base of the tooth buds destined to become the permanent canine and the second premolar. This lucency was undoubtedly associated with the pulp exposure of the deciduous canine and the subsequent influx of bacteria into the surrounding mandibular bone.

Discussion: The importance of treating fractured deciduous teeth cannot be overemphasized and this case is a good example. The pulp exposure of the deciduous canine tooth was responsible for the initial mandibular swelling and serosanguinous discharge associated with the deciduous second premolar. It also eventually led to pathological involvement of the permanent tooth buds resulting in enamel hypoplasia of two teeth and arrested development in another. Any damage that occurs to the developing tooth buds, whether it be traumatic or infectious in origin, can result in defects that may not become apparent until months later when these permanent teeth erupt into the oral cavity.

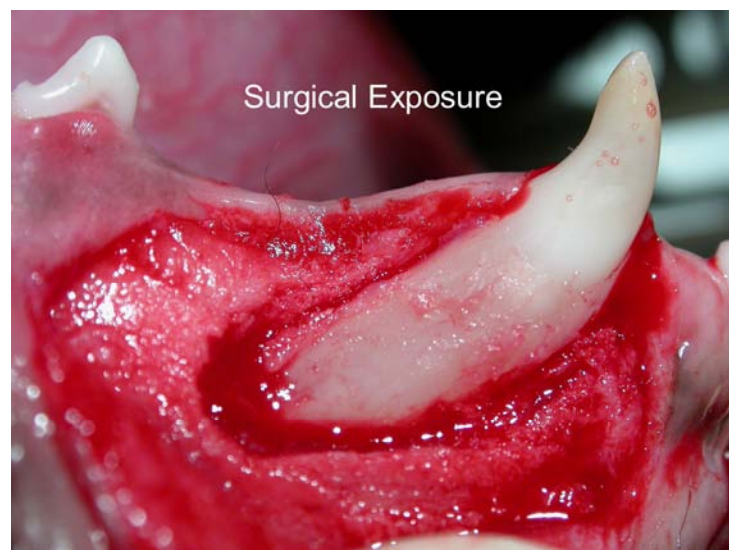
This patient presented again eight months later with an enamel defect on the right mandibular permanent canine tooth. A treatment plan was created to prepare and restore the enamel defect with a composite restoration.

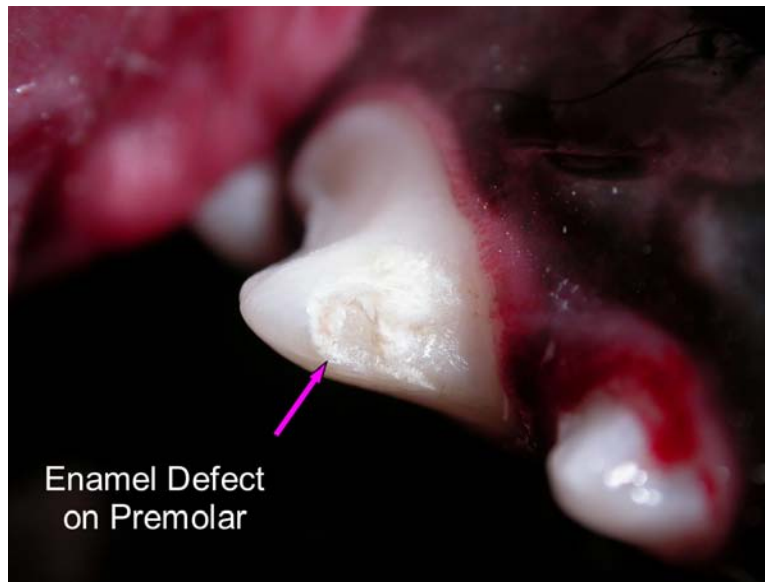
The second premolar was radiographed to be sure there was no endodontic involvement prior to bonding this tooth. This radiograph also showed a non-vital first premolar with large root canal, thin dentinal walls and a wide open apex.
